Tremco Commercial Sealants & Waterproofing

The National Institutes of Health

- Quick Cure Vehicular Deck Coating Technology
- Demanding deadline for an installation of over 92,000 sq ft.

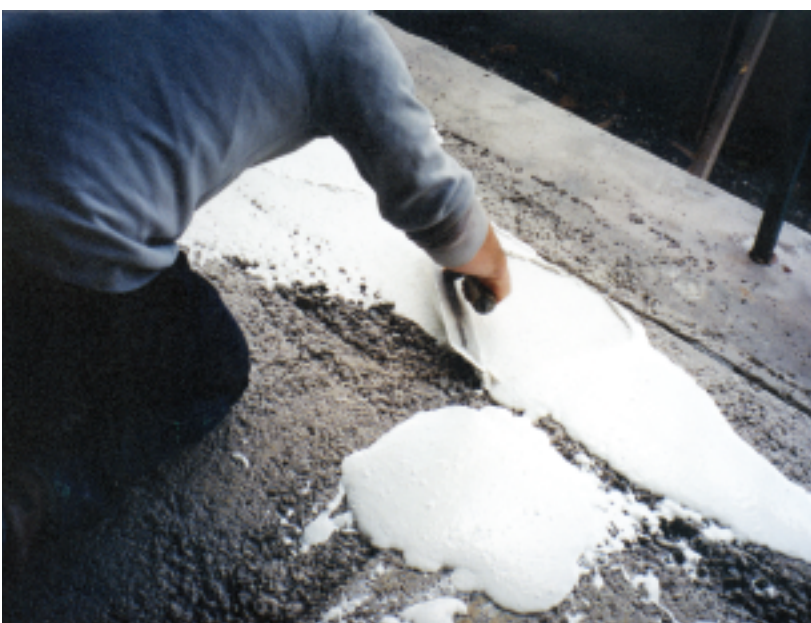
- Spalled concrete needed patching.
- Ability to apply basecoat over patched areas within four hours.

- Detailed all crack and expansion joints with Vulkem® 360NF.
 - Patched all concrete spalled areas with Vulkem 360NF with aggregate.
 - Sloped all vertical to horizontal areas where ponding water was an issue with Vulkem 360NF with aggregate.

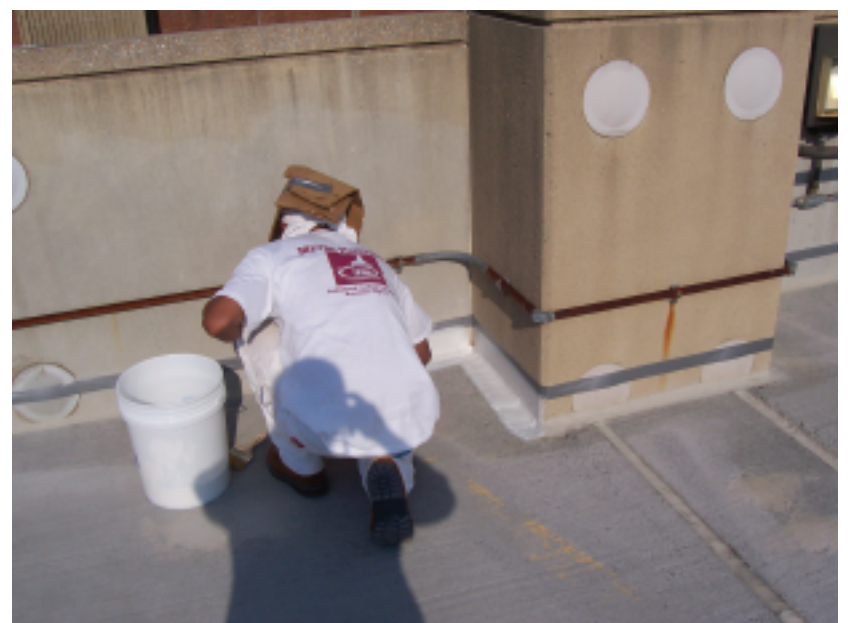
- Sloping water away from vertical to horizontal junctures.
- Ability to apply basecoat over sloped areas within four hours.

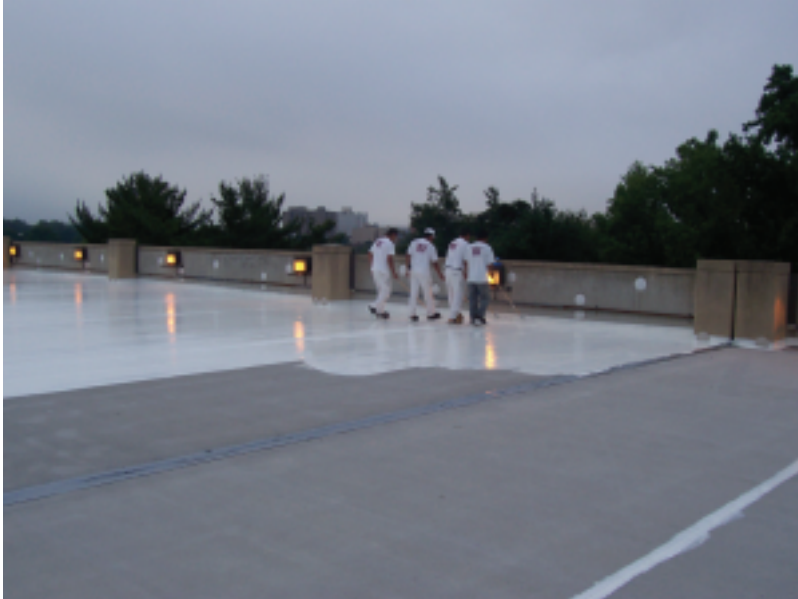
- Need to install an extreme duty vehicular deck coating system which consisted of four-layer system over 92,000 sq feet within a time frame of less than 72 hours.

- Applied 25 mils of an elastomeric basecoat, Vulkem 360NF.
 - Applied two 12 mil layers with backrolled aggregate of high abrasion resistant Vulkem 950NF coating.

- Applied 12 mil layer with backrolled aggregate of Vulkem 951NF for abrasion resistant, UV exposure and chemical resistance.
- Vulkem 360/950/951NF was initially specified on the project, however; the owner went with an additional layer of Vulkem 950NF for additional longevity and additional slip resistance of the deck coating system.

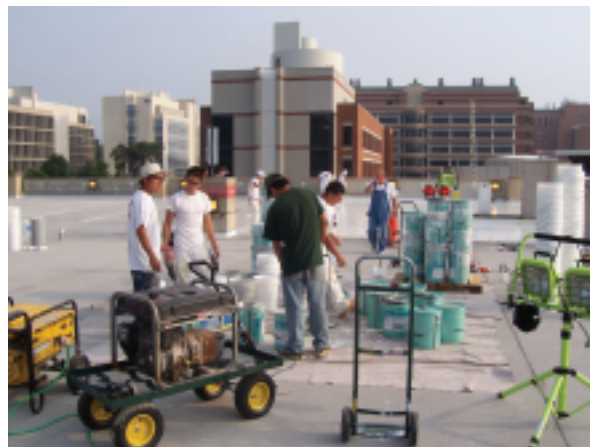
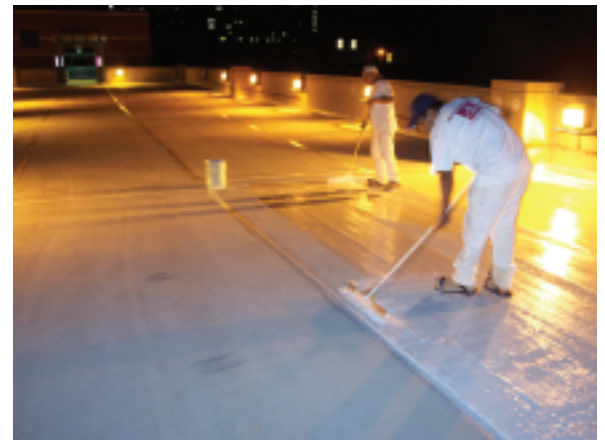
- Had only a three-day weekend to shot blast, patch, slope, detail, and install four layers of coating.
- Ability to staff and stage 24 hours a day with no down time.
- Local availability of product.
